Circle the Wagons: The History of US Army Convoy Security

Richard E. Killblane

Combat Studies Institute Press
Fort Leavenworth, Kansas

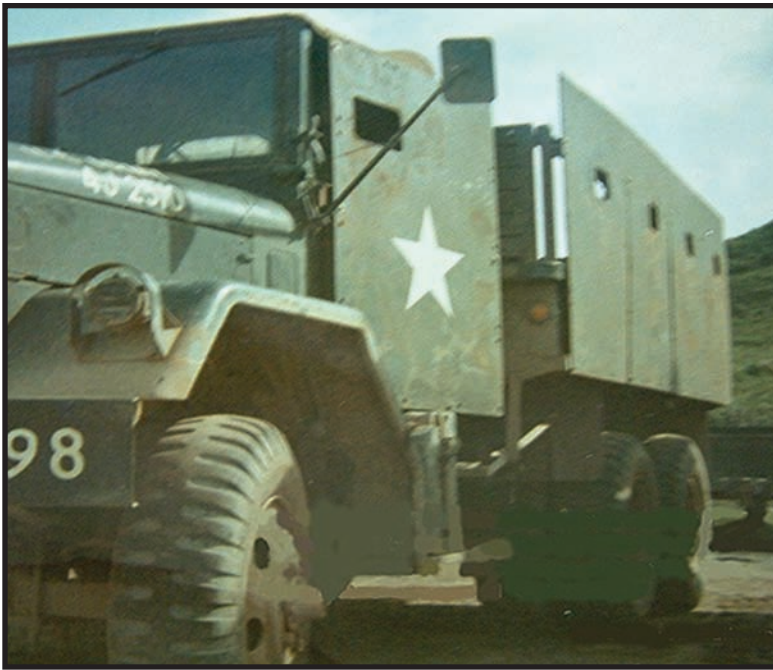
Figure 5. The First Gun Truck.

during World War II; yet, the 8th Group did not have ring mounts and the depot units had no idea what they were and could not order them. As a substitute, Wolfe thought of constructing sandbag pillboxes on the backs of 2½-ton trucks and placing one man in each with an M-60 machine gun. Lieutenant Colonel Phillip N. Smiley, Commander of the 27th Battalion, directed his battalion to build the first two gun trucks.⁴

To protect themselves from mines, the 8th Group crews added sandbags to the floor of their trucks, on the hood in front of the windshields, and even on the fenders. The latter did not work because of the engine's heat and vibration. Warrant Officer Nichols, the group maintenance officer, decided to place steel plating on the sides of the trucks for protection.

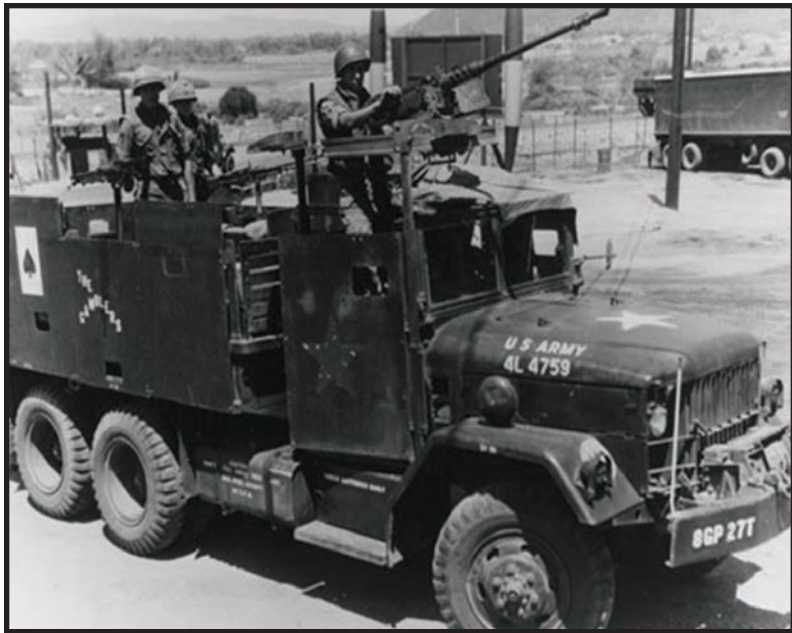
Figure 6. 8th Group 2 1/2-Ton Gun Truck with Steel Plates. This truck has sandbagged floors and two pedestal-mounted M-60 machine guns.

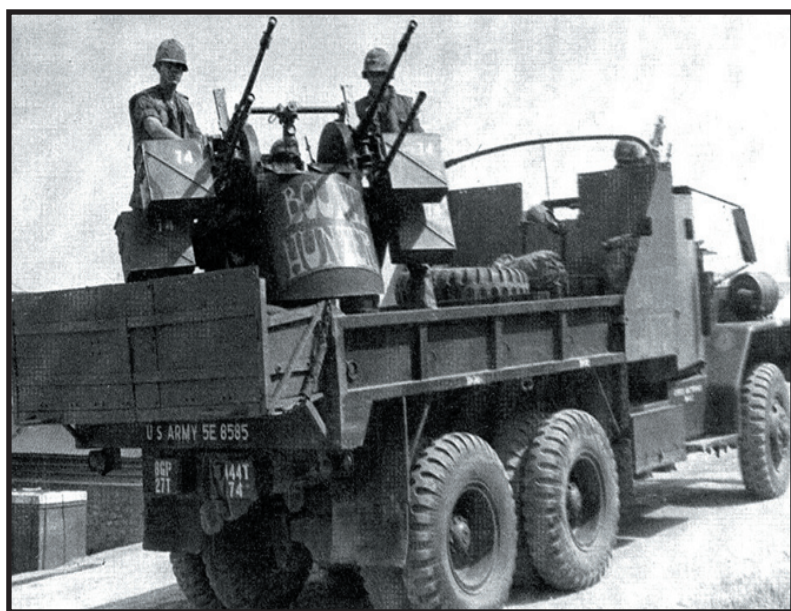
Figure 8. *The Bounty Hunter's* Mounted Quad .50 Caliber.

No weapon system struck more fear in the hearts of the enemy than the Quad .50, but it also had its drawbacks. All four .50 caliber machine guns of the M-55 could only fire in the same direction, could not depress very low below the horizon, and could not traverse 360 degrees because of the truck's cab. On top of that, the four machine guns required four men to feed them ammunition, plus a gunner. The six-man crew was not cost effective and officers often pulled the crew members off for other duties. Rarely did the M-55s have a full crew; therefore, the M-55s fell out of use as other types of gun trucks replaced them.⁴³

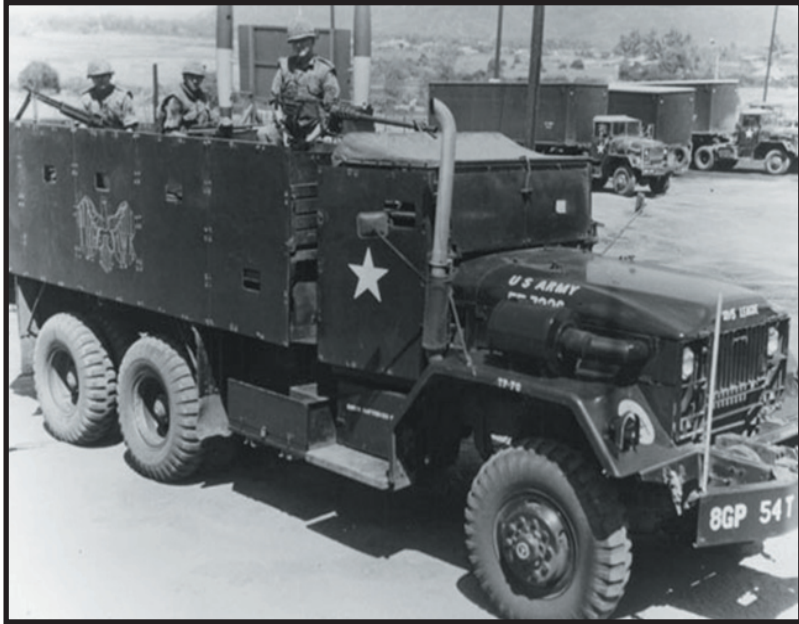
Figure 9. Gun Truck with Gun Ports and Windshield Cover.

These new gun trucks added two M-60 machine gunners in the box. The designers of the kits had cut firing ports in the steel walls thinking the machine gunners could fire their M-60s through them. This was not practical. The gunners preferred to fire over the top of the walls. The first gun trucks were painted olive drab to blend in with the other cargo-laden trucks.

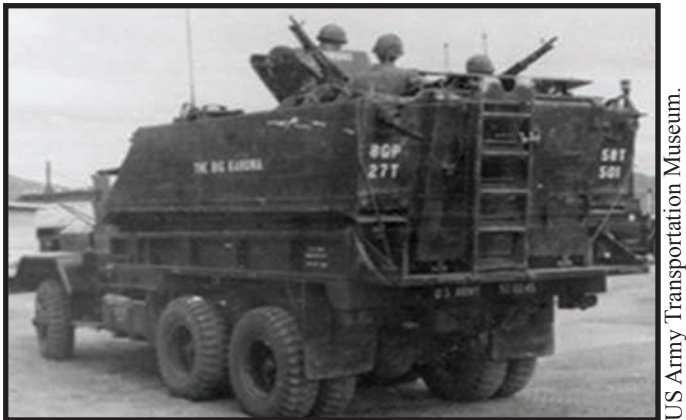
Figure 14. *The Big Kahuna*. APC hull mounted in a 5-ton truck.

This steel shortage caused Bellino to experiment with another idea. 8th Group mechanics mounted a stripped-down APC hull on the back of a 5-ton truck with an M2 .50 caliber and two M-60 machine guns on the top. 8th Group first fielded several APC gun trucks in September 1968. Experimenting further, 8th Group mounted the hull on just the frame of an M54

5-ton truck and another on the bed of a 5-ton. The one loaded on the bed worked best. Colonel Bellino thought this third iteration of gun truck would replace the other types. Unfortunately however, the APC gun truck proved to be very top heavy, hard to drive, and dangerous on turns. The crews of the 8th Group loaded their APC hulls with front forward. This placed most of the weight over the back wheels. The crews down at Cam Ranh Bay loaded their APC hulls in backwards. This distributed the weight more evenly over both the front and rear wheels. Even so, the excessive weight was hard on the vehicle since it required more maintenance to keep it road ready. Its armor offered less protection than double steel panels with filler material and it did not have the firepower of a box-type gun truck. By 1970, complaints had reached 8th Group headquarters, who decided to eventually discard the APC gun trucks. A few did survive in I Corps. The box-type gun truck remained the favorite among crews.⁴⁶

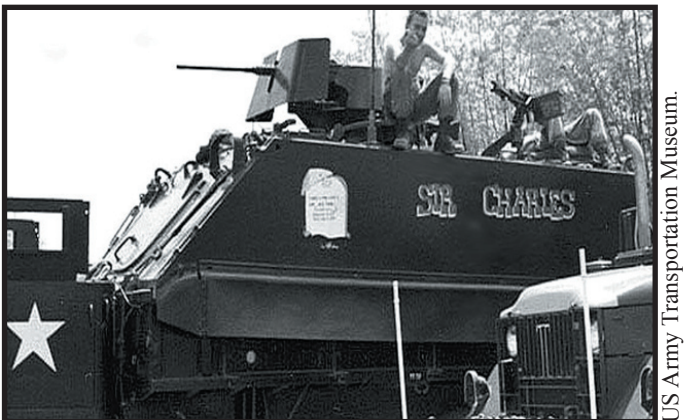
Figure 15. *Sir Charles*, M113 APC Hull.

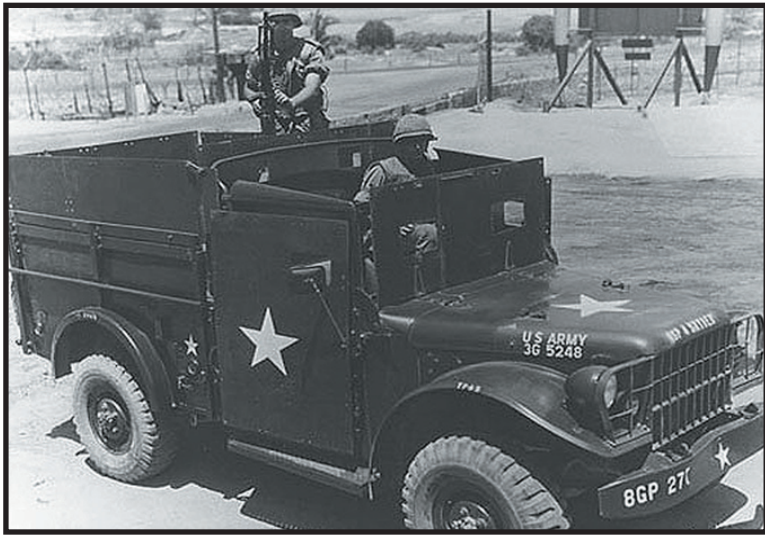
Figure 16. 3/4-Ton Truck.

During 1968, the 8th Group also armored M37 3/4-ton trucks and mounted a machine gun on a pedestal in the back and called them gun “beeps.”

They could only carry thin armor, but offered better protection than an M151 1/4-ton jeep. The added weight did cause considerable wear and tear on the vehicles though. 8th Group also tried using 3/4-ton gun trucks for convoy security but they did not work well either. The gun “beeps” were relegated to administrative runs to Qui Nhon or to driving around at night in unsecured areas.⁴⁷

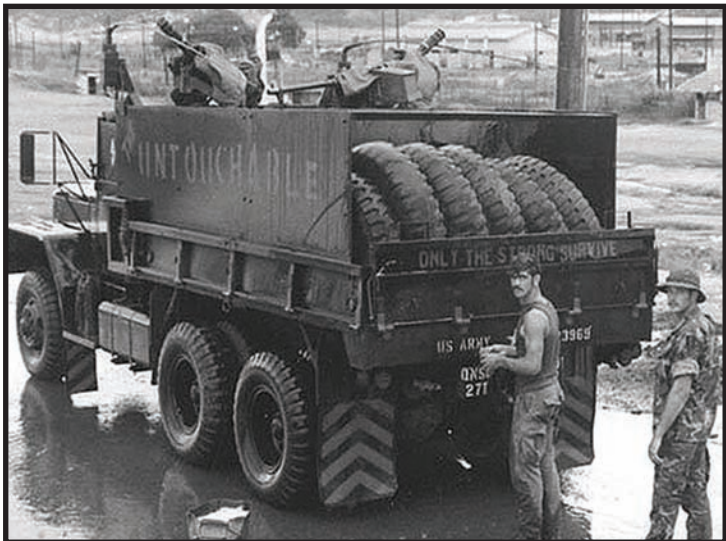
Figure 18. *The Untouchable*, M134 Gatling Machine Gun.

Armament evolution began with hand-carried M-60 and ring-mounted .50 caliber machine guns. Gun truck noncommissioned officers in charge (NCOIC) learned that ring mounts could not effectively traverse 360 degrees, so that machine gun was moved to a pedestal in the box. It was also discovered that the peripheral vision of two men did not encompass 360 degrees. Therefore, the gun truck progressed to a crew of three men in the box. Soon crews mounted all machine guns on pedestals for control and accuracy. As had been learned by earlier truck drivers in the Korean War, the .30 caliber and later 7.62mm (M-60) machine guns were not nearly as intimidating as the M-2 .50 caliber (see Figure 17). The .50 caliber machine gun could shoot through almost anything. By 1969, crews replaced their pedestal mounted M-60s with .50 caliber machine guns or even M134 7.62mm Gatling machine guns, or mini-guns. The mini-gun was the most intimidating, but it tended to jam (see Figure 18). Gun

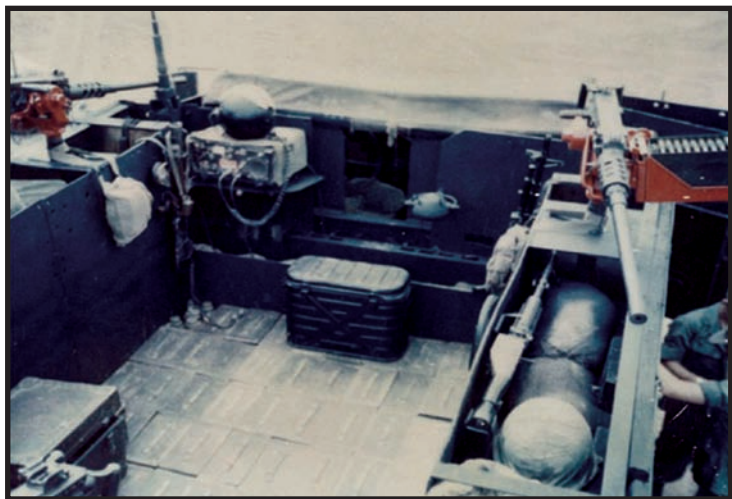
Figure 19. Ammunition-Laden Gun-Truck Floor.

Another important factor adding to the gun truck’s firepower was the amount of ammunition carried. The basic load for a combat-service support unit was considerably lower than that of the combat arms. However, the machine gunners were amazed at how much ammunition they could fire in just a few minutes. The crews quickly increased the amount of ammunition they carried in the gun trucks, covering the entire floor with ammunition cans (see Figure 19). Essentially, a gun truck took as much ammunition as

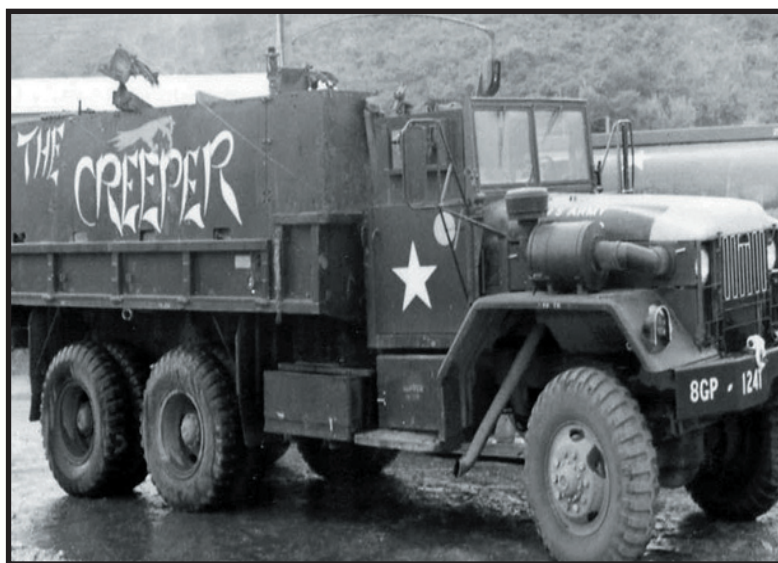
Figure 21. *The Creeper's* Bullet-Proof Windshields.

In 1969, gun trucks also received new bullet-proof windshields since the others were impractical. Instead of ports, the new windshields had pre-cut rectangles with slots for two 2-inch thick bullet-proof sheets of glass. These began to see widespread use on gun trucks. If damaged, the old glass could be slid out and be easily replaced with a new sheet.

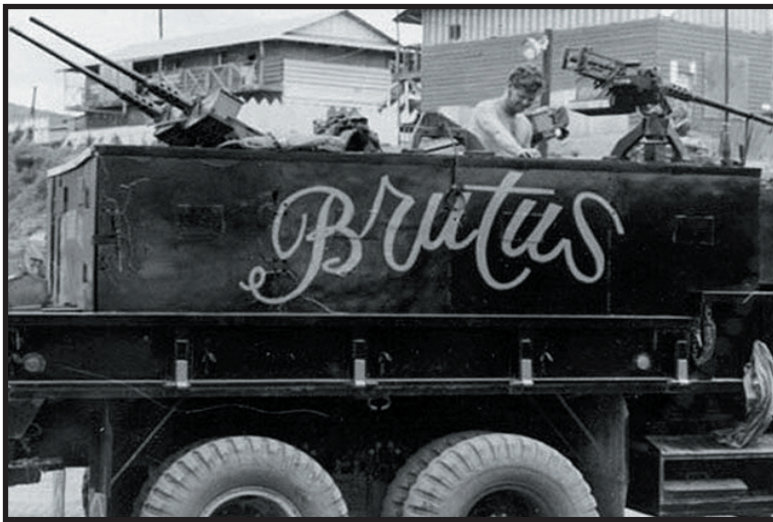
Figure 22. *Brutus*, Three .50 Calibers in a Big Iron Box.
